U.S. DEPARTMENT OF
ENERGY

OFFICE OF
**ENVIRONMENTAL
MANAGEMENT**

July 14 Storm Damage Summary

**Citizen Task Force Meeting
September 23, 2015**

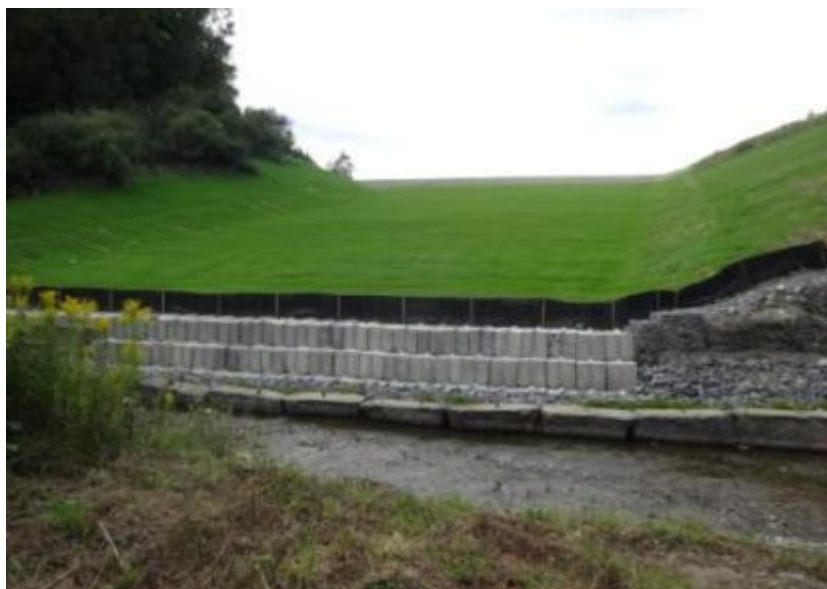
Lake 1 Spillway Before the Storm

- A topographic survey of the Lake 1 Spillway was performed to capture current condition and plans for short-term clean-up response actions
- Engineer of Record reported no immediate threat to Lake 1 Spillway or Lake 1 Dam

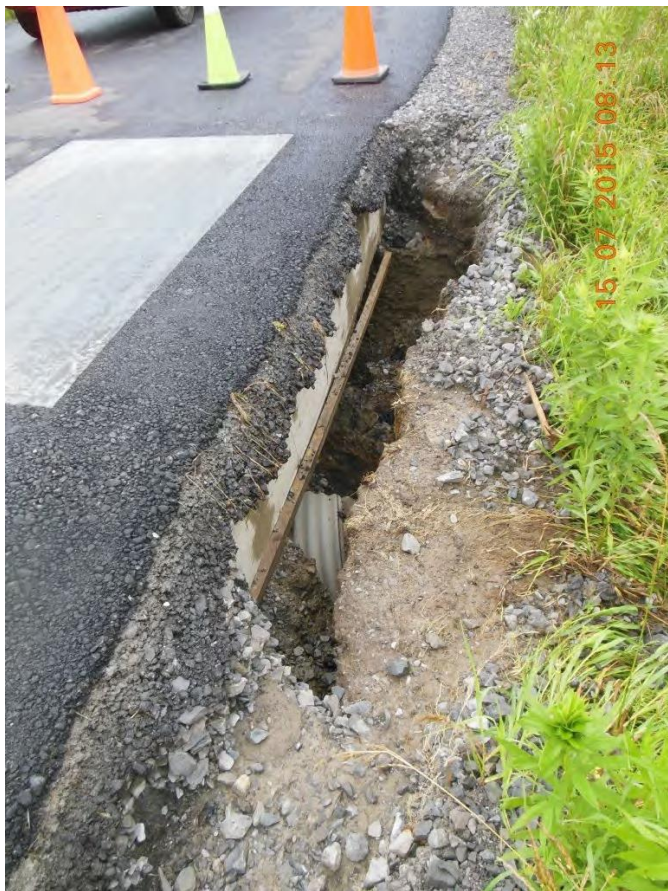
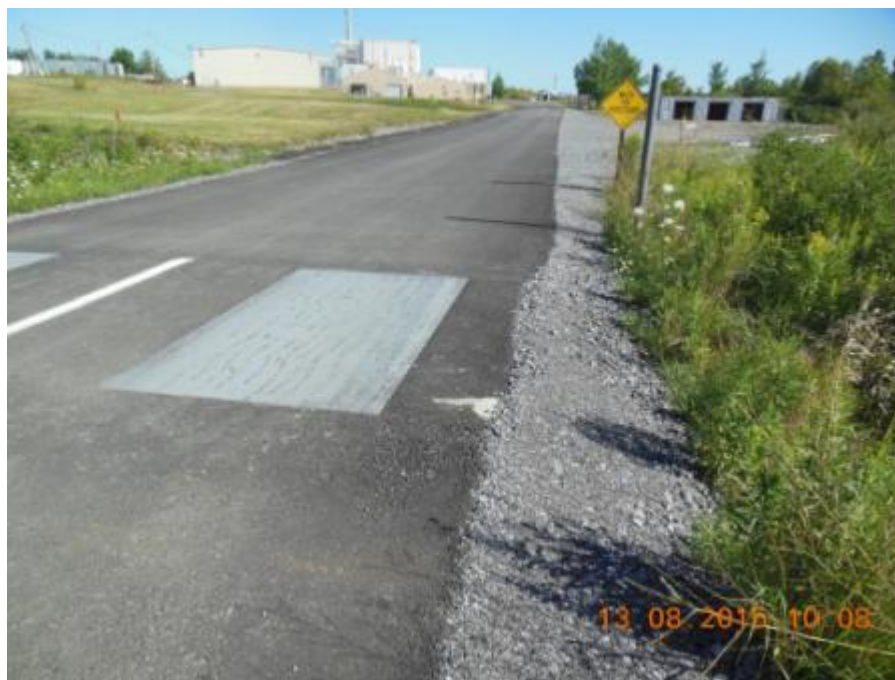
High-Level Waste Haul Path

- On July 15, the extent of damage under the Haul Road in the Erdman Brook area was evaluated
- Haul Path erosion damage caused by heavy rains the previous week were repaired on July 17

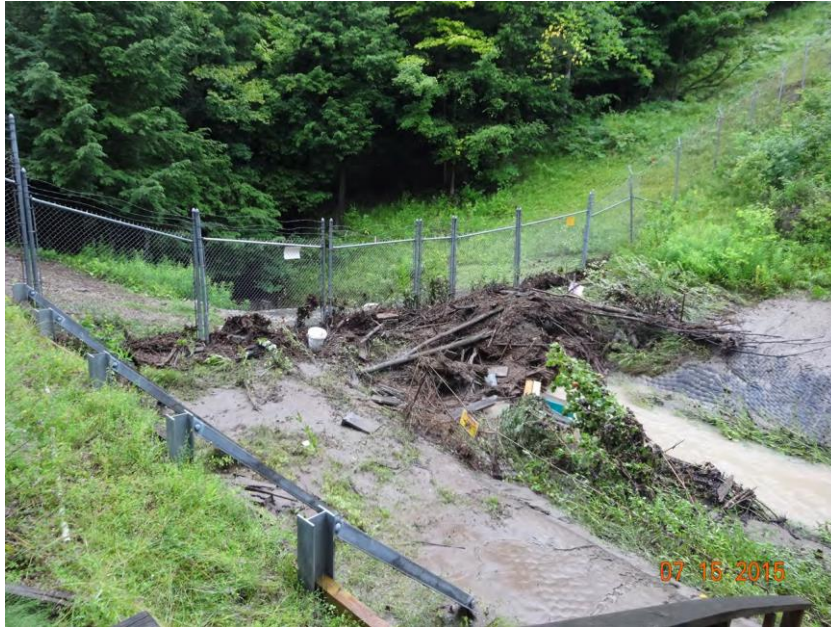
Erosion occurred upstream of the Parshall Flume (located in Franks Creek) with debris accumulation at discharge pipes in Parshall Plume cleared; debris must be cleared

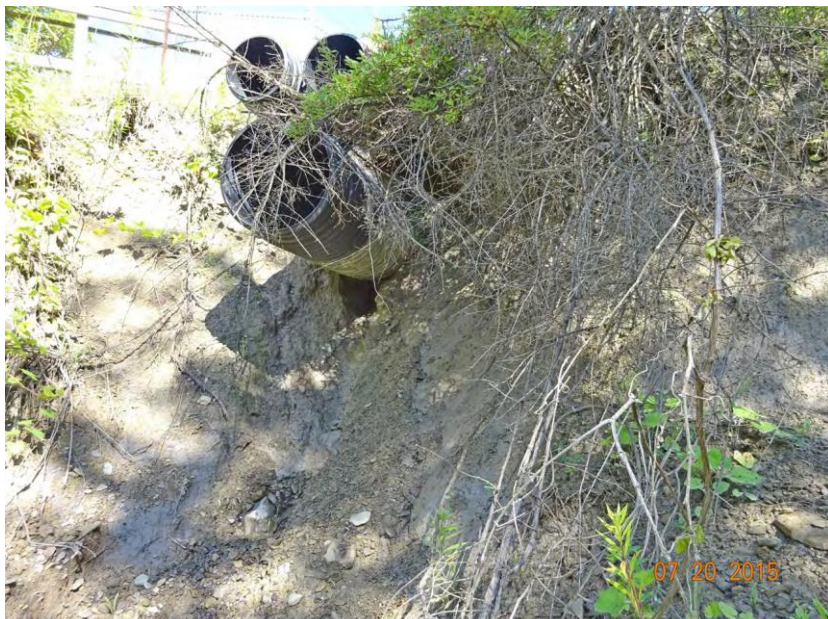
**Additional Erosion of S-09 Discharge Pipes
Caused by the Storm**

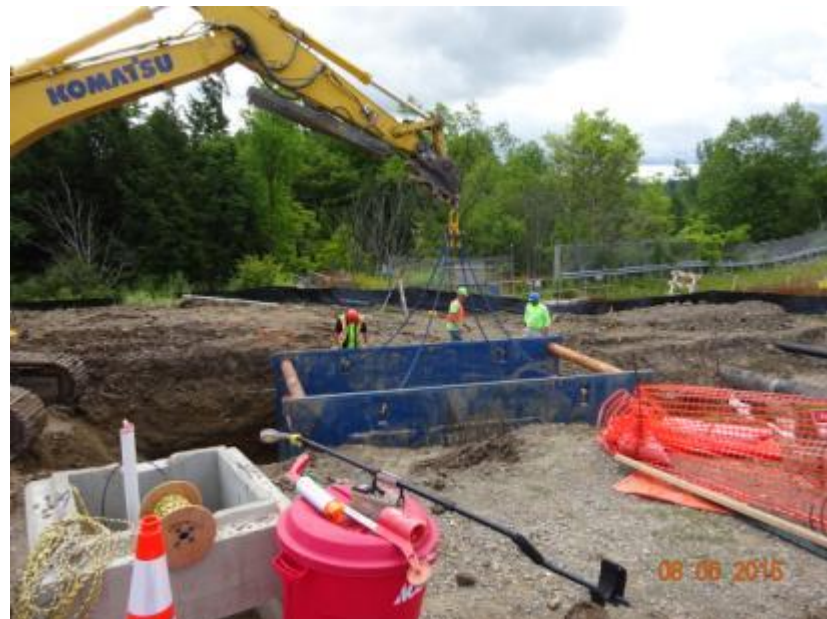
**Progress Continued with the Storm Water Outfall
Relocation Project**
