NYSERDA

July 14 Storm Events and Effects on Erosion Controls in Erdman Brook and Frank's Creek

September 22, 2015

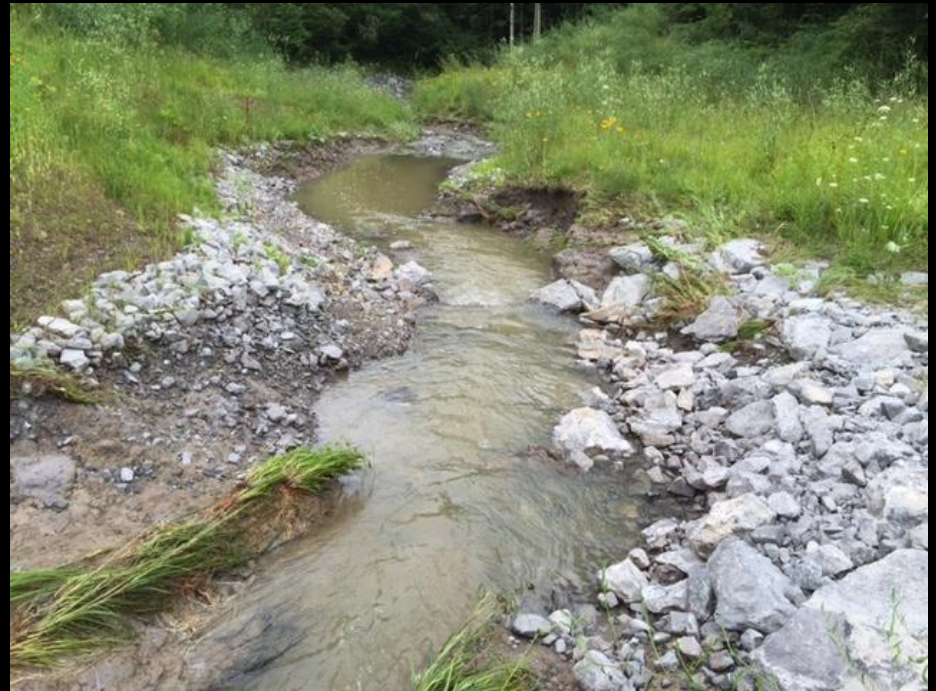
- Erosion controls functioned as designed
- Grade control structures withstood the high flows
- Some channel armoring (rip-rap) was displaced
- On Frank's Creek, some scour (erosion) of the stream banks and stream bed occurred.
- Effects not unanticipated – erosion controls not designed to be permanent installations, would require maintenance

- Repairs will be performed on Erdman Brook and Frank's creek this year
- Repairs will generally be to replace in kind, with certain enhancements
- Enhancements include additional stone check dams and weirs intended to further reduce flow velocities and dissipate energy during large storm events.
