NYSERDA

SDA Trench Leachate Elevation Update

Citizen Task Force Meeting

January 24, 2018

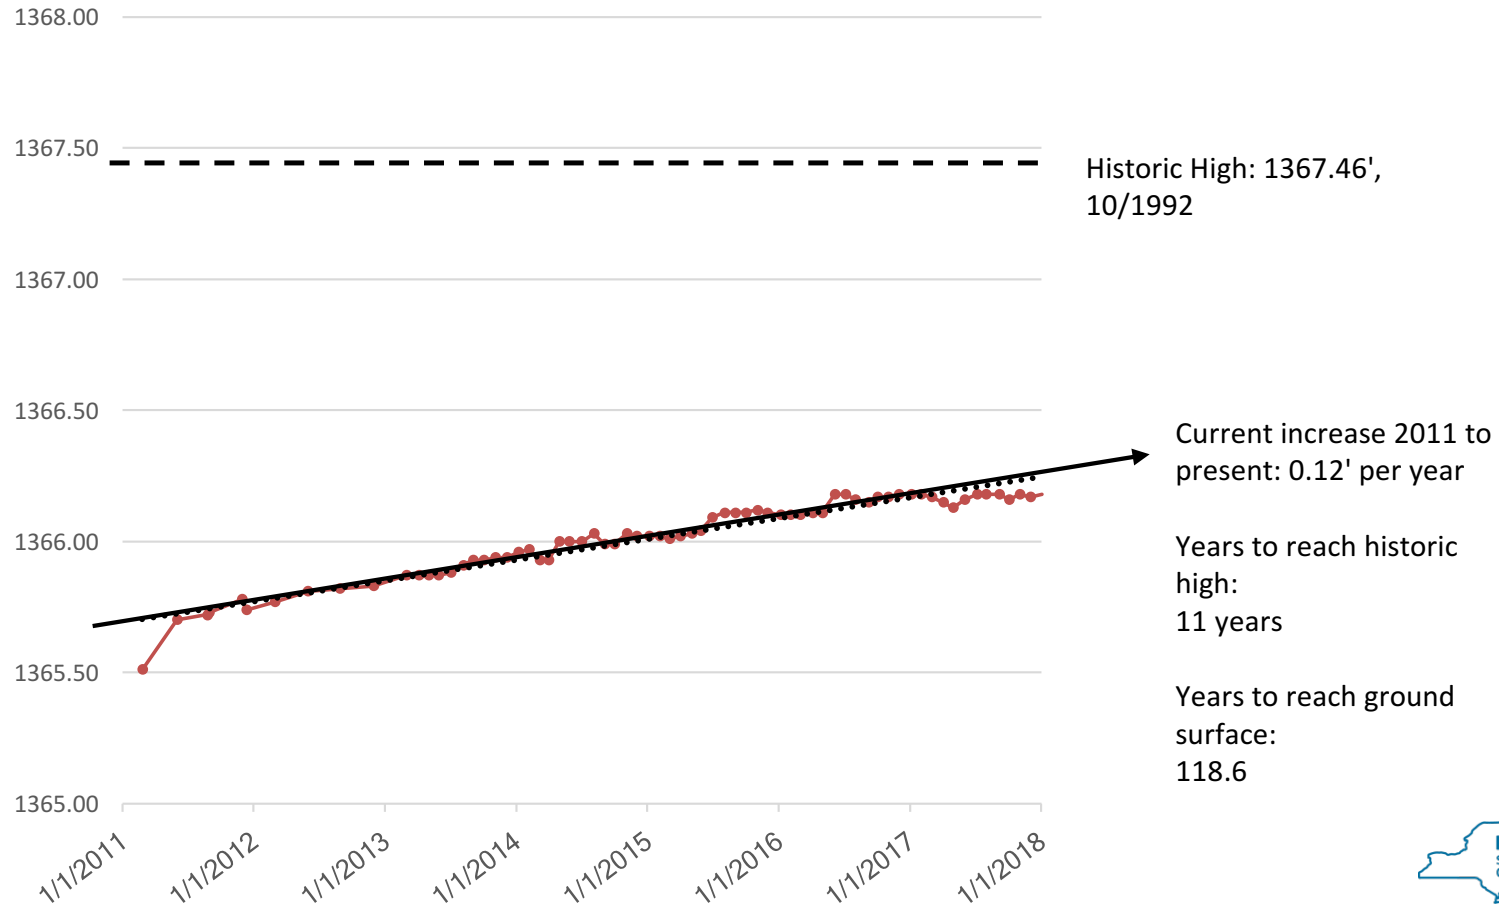
Trench 14 Projection – Leachate Elevation (ft. AMSL) 2011 to Current

- Leachate elevations have been generally decreasing since infiltration controls were installed in 1992-1993.
- Increases were noted in early 2011.
- 2011-2015 data show small increases continued.
- 2016 to current data show stabilization.
- Total increase since 2011 is 0.67 feet (8.04 inches).
- Change does not represent a public health and safety issue.

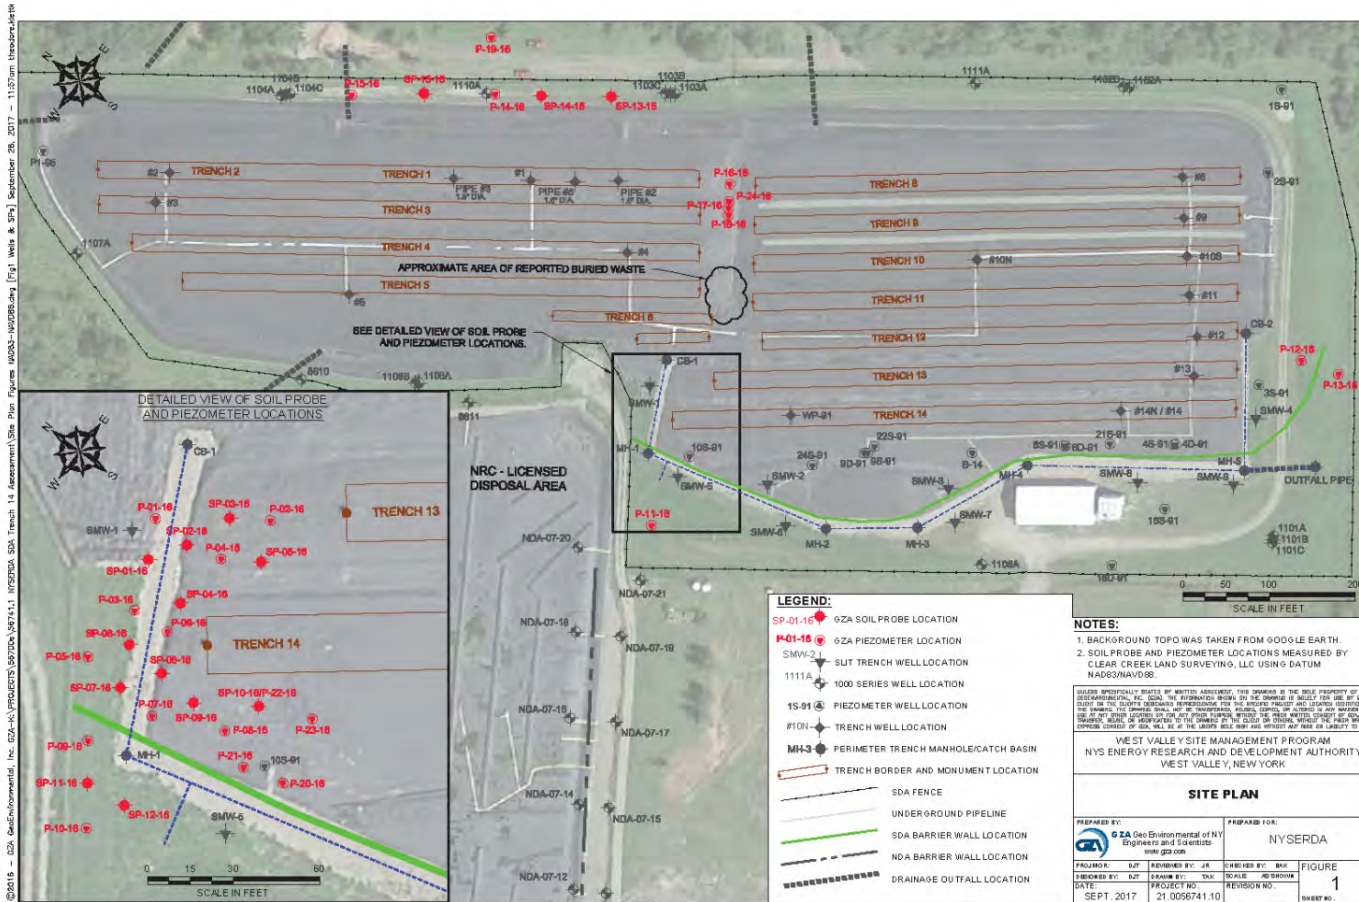
GZA Soil Probe and Piezometer Location Plan

- GZA Final Report (est. March 2018): An preliminary evaluation of the results from the 2016 field activities indicates that the increases in Trench 14 are likely due to an influence on the north end of the trench, that groundwater is not infiltrating Trench 1 from the east or south side of the trench and that groundwater is not infiltrating Trench 3 from the south end of the trench.

- Installation of Telog groundwater elevation measurement devices at select piezometers.
- Ongoing bi-weekly collection of water level measurements at all new piezometers.
- Recommendation to focus additional subsurface activities on the north end of Trench 14 due to the presence of a groundwater “high” area.
- GZA currently working on a work plan to further address the area north of Trench 14 for installation of additional piezometers for soil screening, geology, groundwater sampling, and groundwater elevation monitoring.

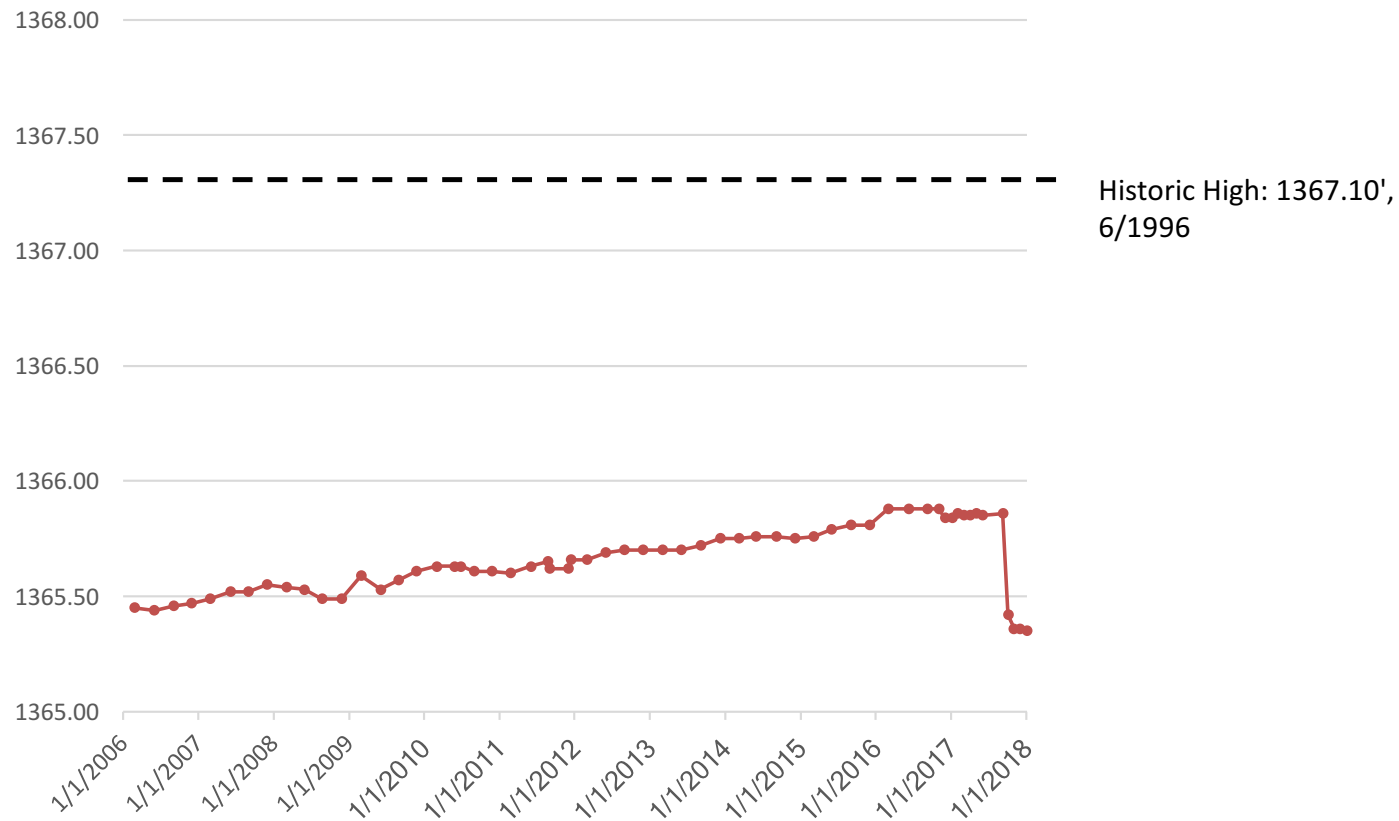
Trench 1 Projection - Leachate Elevation (ft. AMSL) 2006 to Current

- Leachate elevation had been generally decreasing since 1996.
- Increases were noted in 2006.
- 2006-2017 data show small increases continued.
- Leachate sampling in September 2017 indicate that fluid in the area of the sump is likely localized. Further investigation is being considered.
- Change does not represent a public health and safety issue.
