West Valley Demonstration Project

Project Update

Bryan Bower
DOE-WVDP Project Director
May 26, 2010
Citizen Task Force Meeting
www.em.doe.gov
www.wv.doe.gov

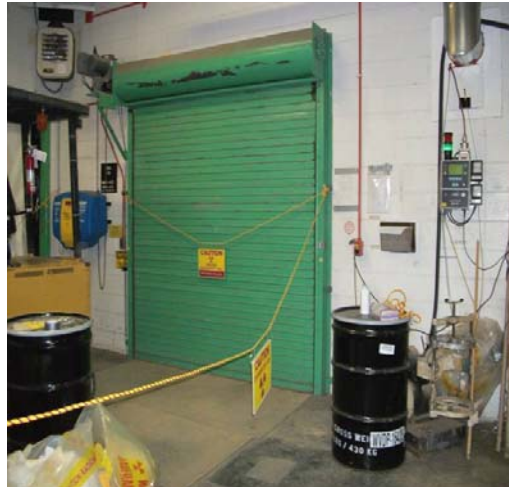
- ◆ On May 10, four operators were contaminated while bagging waste out of a contaminated area in the Main Plant
- ◆ Waste included anti-contamination clothing debris, and components from Extraction Cell-3

- A time out was taken and a critique was performed. Management concluded that improvements were necessary with regard to:
 - Stopping when conditions are different than planned and briefed
 - Waste boxes need to be as close as possible to waste generation
 - All materials must be radiologically cleared prior to movement from contamination area to a radiological buffer area
 - Sharp and protruding objects must be covered to prevent bag damage
 - Bagging and sealing techniques for waste need to be reinforced
 - Waste needs to be dispositioned in a timely manner
 - Investigate procedure changes to allow modified (safer) techniques for handling and disposing of pipe
- All workers were briefed on the incident and corrective actions before resuming work

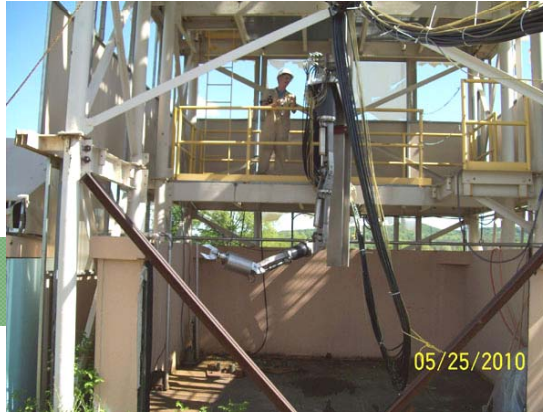
The robotic arm that will be used to dismantle the equipment inside XC-1 is being tested at the Test Tower

- Extraction Cell-1(XC-1)
 - Removed outer hatch covers and relocated to FRS
 - Removed inner hatch cover and placed in waste box
 - Completed core drilling for installation of in-cell camera and utilities
 - Testing robotic arm at Test Tower

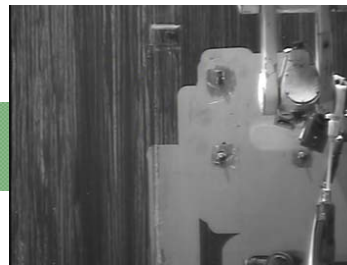
In-cell Nitrocision®
images obtained
from video capture

- Process Mechanical Cell
 - Nitrocision® is effective with removing paint and fixative from cell walls
 - 75% of cell wall penetration areas now cleaned
 - Working on penetrations on west wall
 - Vacuum system deployed
 - Expect to obtain rad data next month

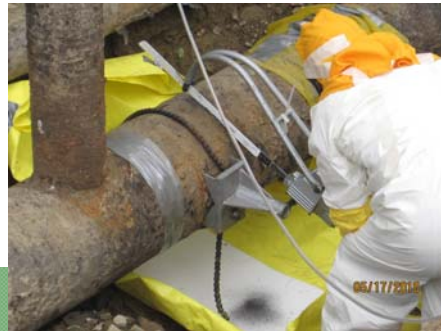
New ventilation lines installed in Tank Farm to prepare for connection to T&VDS

- Ventilation Line Replacement Underway
- New above ground ventilation lines installed in Waste Tank Farm
- Rotary Dryer moved into place
- Temporary ventilation lines in place and operational
- Existing ventilation header removal in progress
