State-Licensed Disposal Area at West Valley: 2022 Annual Report

Final Report | March 2023

State-Licensed Disposal Area at West Valley

2022 Final Report

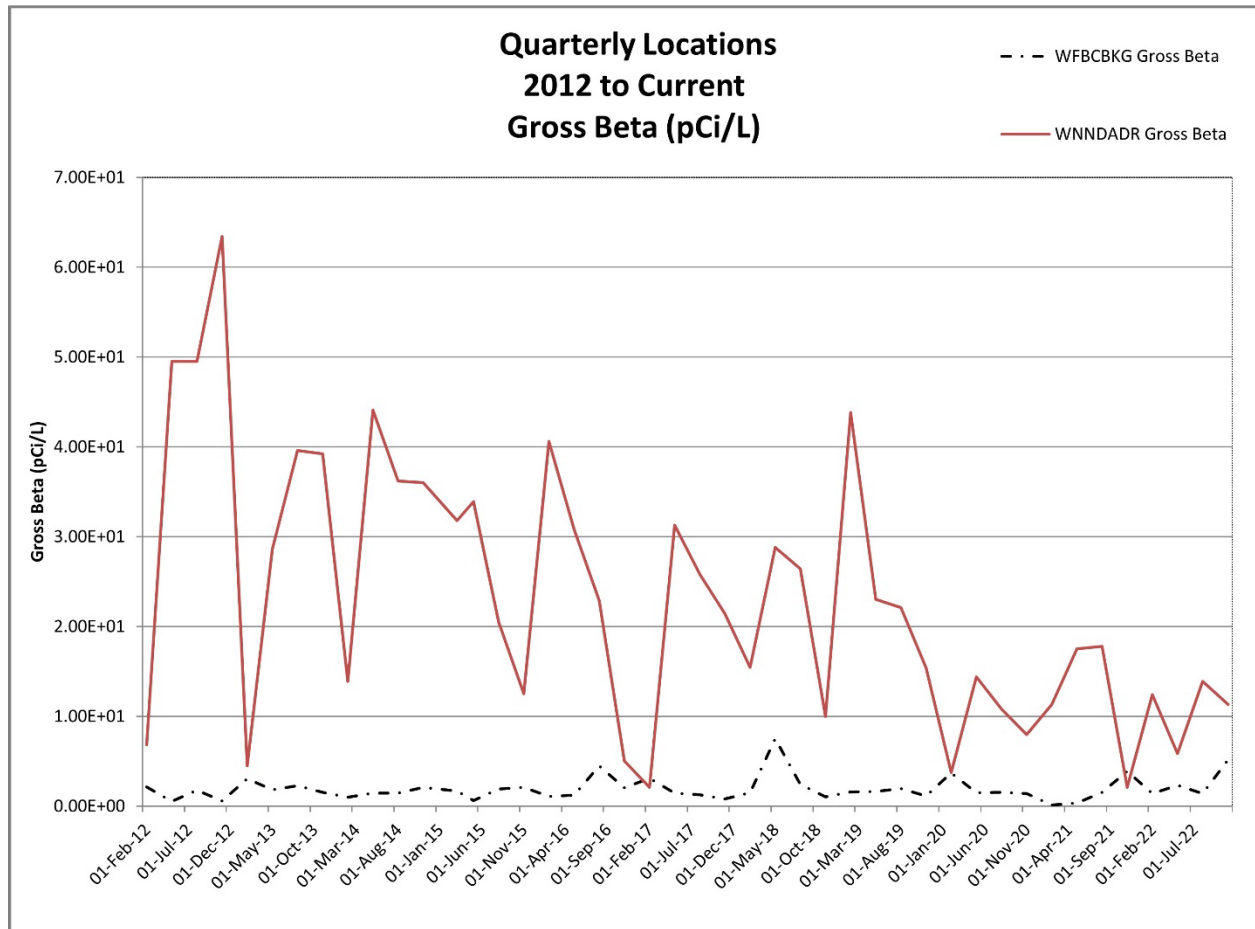
Figure 2-5. Gross Beta Results for Surface Water Monitoring Locations WNNDADR Compared to WFBCBKG

The 2022 gross beta results for WNDCELD, WNFRC67, and WNERB53 were statistically indistinguishable from background. Gross beta results for WNNADR were statistically higher than background; however, the results continue to decrease since the NDA geomembrane cover and subsurface barrier wall were installed in 2008.

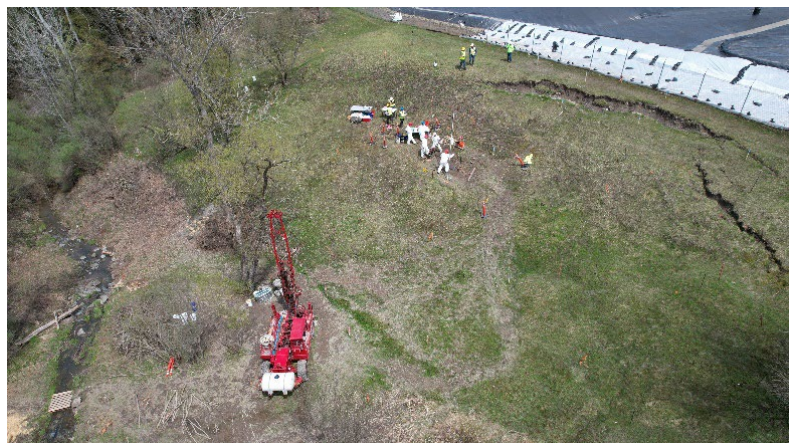
Figure 4-2. Aerial view of Geotechnical Investigation

In the spring of 2022, NYSERDA’s contractors installed 22 soil borings to determine the source of the soil slumping along the North Slope (see Figure 4-2). The borings were monitored for movement and based on the data collected, the investigation concluded that the soil slumping was in the soil that had been placed on the North Slope during the mid-1960s construction of the SDA trenches, and the soil slumping was not occurring in the deeper soils on the slope.

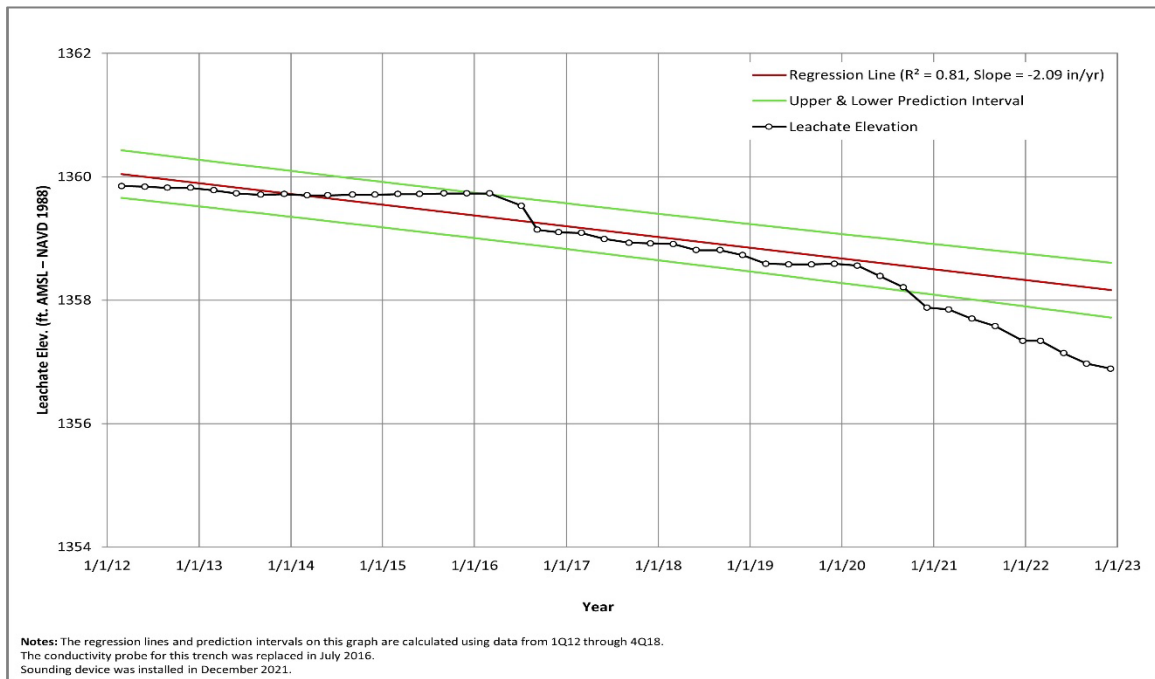
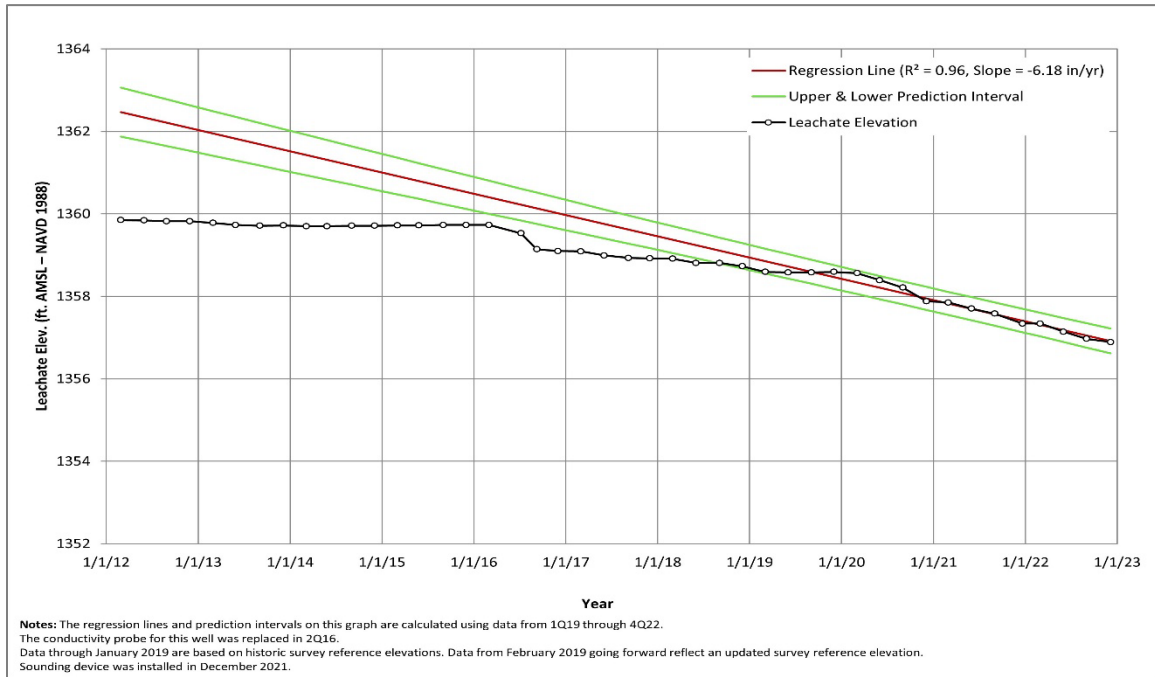
Figure A-4. 2012 – 2018 Leachate Elevations, Trench 3

Figure A-5. 2019 – 2022 Decreasing Leachate Elevations, Trench 3

Trench 3 had been exhibiting a decrease of 1.88 inches per year through the end of 2019. Beginning in 2020, the rate of deceleration increased to 2.10 inches. In 2021, the deceleration increased to 5.8 inches, and in 2022, the rate of deceleration was 5.4 inches. The change necessitates a separate regression line for the Trench 3 graph to accurately demonstrate current leachate trending conditions at this location (see Figures A-4 and A-5). The trend in Trench 3 continues to be evaluated and an evaluation of the trench sump conditions for Trench 3 is also planned for 2023.
