# OLEAN TIMES HERALD

March 13, 2024

## WVDP employs video tech to improve waste tank inspection

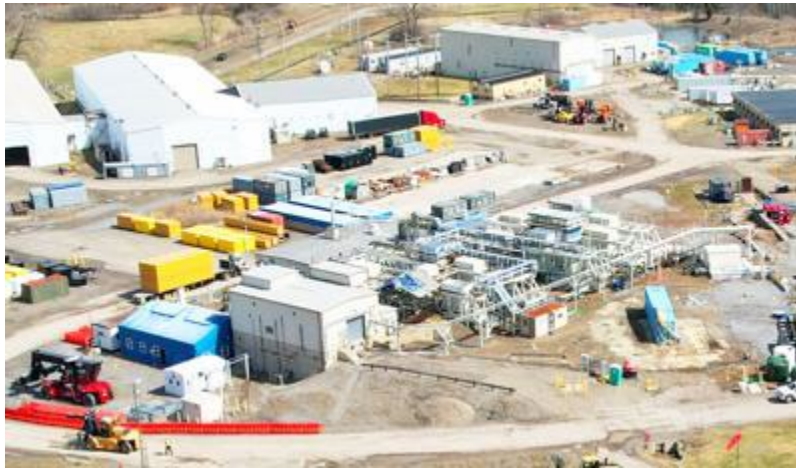
A tank where DOE crews performed a video inspection is located in this grouping of underground waste tanks at the West Valley Demonstration Project.

DOE acquired a high-definition, radiation-resistant video camera and light assembly used in nuclear and non-nuclear applications. The camera, which also has pan and tilt capabilities, was lowered into the tank with sleeving to minimize camera and cord contamination. Once workers obtained video footage inside the tank, the camera was removed, surveyed as clean and released for future use.
